**Flood Control Project Maintenance
Levee Inspections**
LMA District Cover Sheet
Spring 2019 Levee Inspection Results

Reclamation District No. 1600 Mull

Spring 2019 Levee Inspection Results

Waterway			Bank	Unit Miles
Unit No. 01 Sacramento River			Right	10.46
	Spring (March - May)	Summer (June - August)	(September - November) Fall	Winter (December - February)
Unit Maintenance Rating (Fall Only)				
Date of Inspection	3/5/2019 - 3/7/2019			
DWR Inspector	Zach Jojola			
Accompanied By	Alberto De Leon DWR

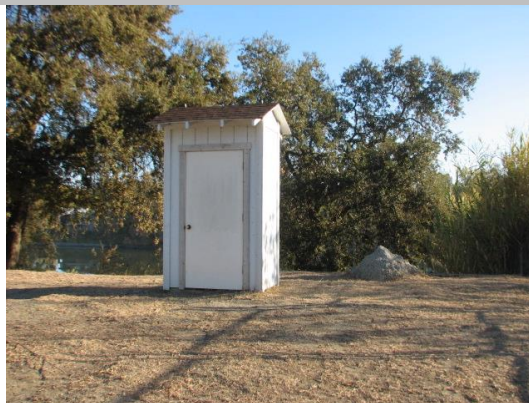
Photo 1 of 2 : SP_2019_RD1600_191_129_20190304_00032.jpg

The small building is a pump house for the well. It services the house with water. Fall 2013

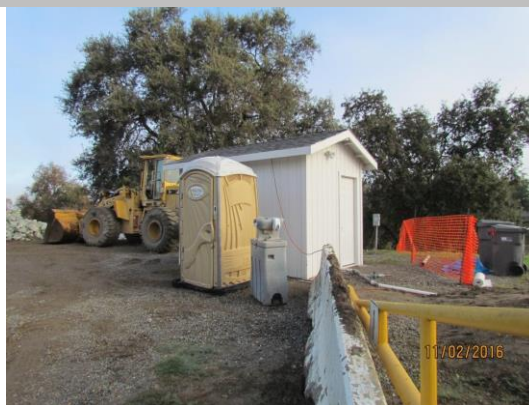
Photo 2 of 2 : SP_2019_RD1600_191_129_20190304_00033.jpg

View of the building. Fall 2016.

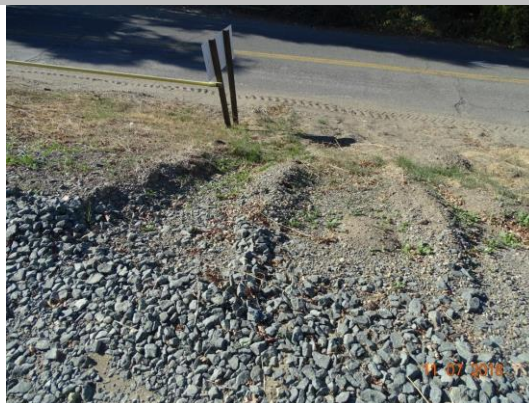
Photo 1 of 1 : SP_2019_RD1600_191_38_20190304_00021.jpg

LM Start	0.11	Rating **	M	Issue No.	38
LM End	0.11	Issue Type +	Ma	Location *	LS
Category	Earthen Levee			GPS Latitude/Longitude	
				Start	End
Item	Slope Stability			38.676524 °	38.676524 °
				-121.631245 °	-121.631245 °
DWR ID	DWR_RD1600_01_f_2018_38				
Comment Code					
S3 : Repair the levee slope damaged by vehicle traffic and prevent access where possible.					
Inspector Comment					
Vehicle ruts on the landside slope.

View of ruts on the landside slope. Fall 2018.

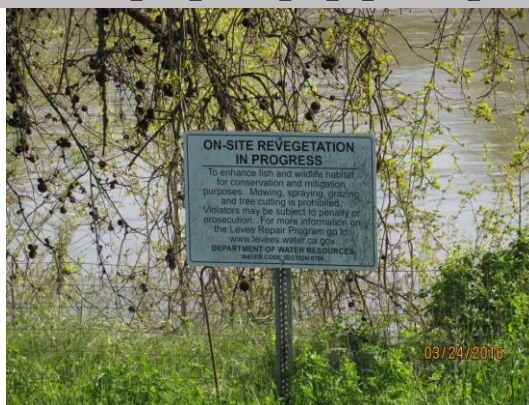
Photo 1 of 2 : SP_2019_RD1600_191_49_20190304_00025.jpg

LM Start	0.11	Rating **	A/W	Issue No.	49
LM End	0.23	Issue Type +	Ob	Location *	WS
Category	Earthen Levee			GPS Latitude/Longitude	
				Start	End
Item	Vegetation			38.676577 °	38.678131 °
				-121.631290 °	-121.632324 °
DWR ID	DWR_RD1600_01_s_2012_49				
Comment Code					
V8 : Environmental Requirements.					
Inspector Comment

Sign stating revegetation site. Spring 2016.

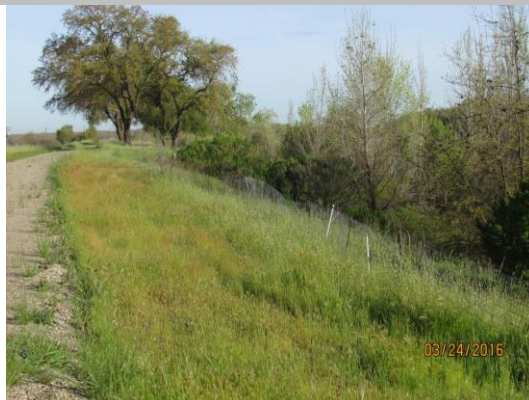
Photo 2 of 2 : SP_2019_RD1600_191_49_20190304_00026.jpg

View of the revegetation site and fence on the waterward side of the levee looking upstream. Spring 2016.

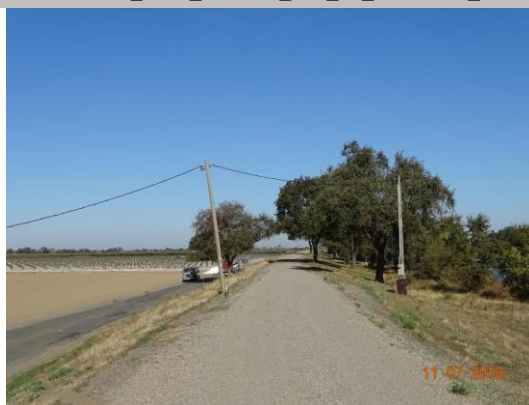
Photo 1 of 2 : SP_2019_RD1600_191_44_20190304_00023.jpg

View of telephone line over levee crown. Fall 2018.

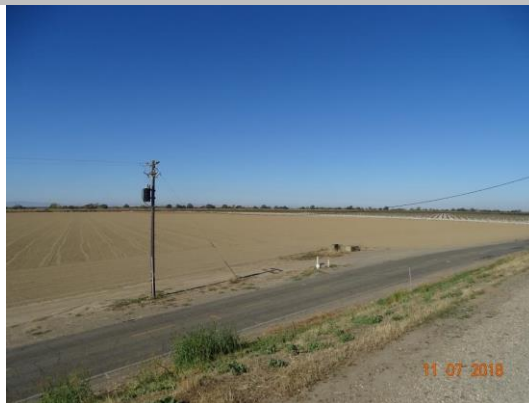
Photo 2 of 2 : SP_2019_RD1600_191_44_20190304_00024.jpg

View of line running to pole on the other side of County Road 117. Fall 2018.

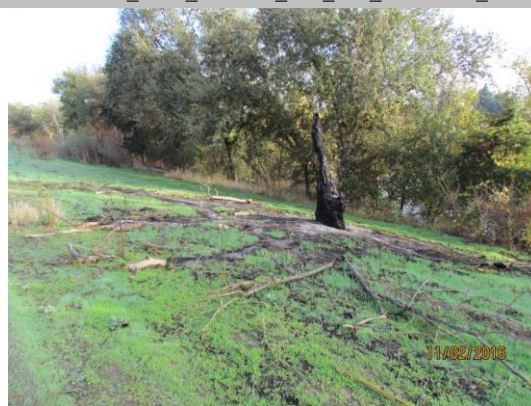
Photo 1 of 1 : SP_2019_RD1600_191_624_20190304_00037.jpg

LM Start	0.78	Rating **	N	Issue No.	624
LM End	0.78	Issue Type +	Ma	Location *	WS
Category	Earthen Levee			GPS Latitude/Longitude	
				Start	End
Item	Trim / Thin Trees			38.685713 °	38.685713 °
				-121.634985 °	-121.634985 °
DWR ID	DWR_RD1600_01_s_2017_624				
Comment Code					
T5 : Tree stumps.					
Inspector Comment					
Burnt stump on waterside slope.

View of burnt tree on waterside slope. Fall 2016.

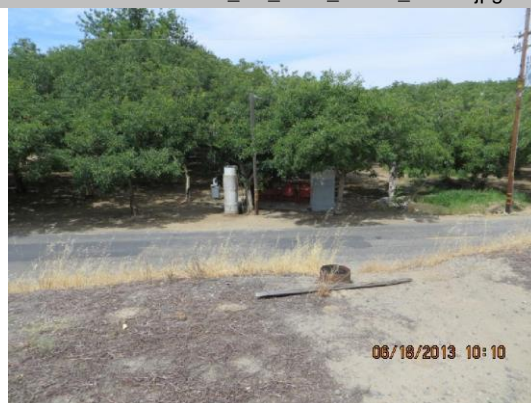
Photo 1 of 3 : UCIP_SP_2019_15285_25088.jpg

Comment Code					
Inspector Comment					
FS_ID:15285 DS_ID:21463 EP_NO: 6100 Repair Type: Non-Urgent Crossing Status: Found UCIP Comments: Gate valve will not open or close. FIELD_STRUCT_DESC: 12-inch steel irrigation pipe through the levee, 3.4 feet below the crown. Slant pump and gate valve on the waterside (WS) slope. Siphon breaker in a 12-inch steel riser on the landside (LS) shoulder. Filter, booster pump, and butterfly valve on the LS toe. 2.25-inch galvanized iron electrical conduit at the same location. (Permit No. 6100, 1968 - Charles Plumb Jr., replaced 8-inch pipe at same location). [Additional Reference(s): DWR Levee Log, 1988]. FS Date: 6/18/2013

Siphon breaker in steel riser on LS shoulder and concrete standpipe off LS toe.

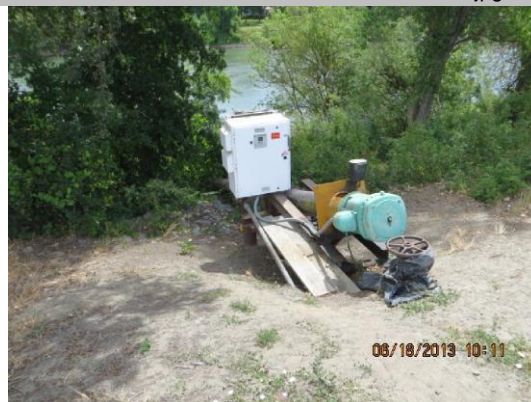
Photo 2 of 3 : UCIP_SP_2019_15285_25087.jpg

Pump and gate valve on WS slope.

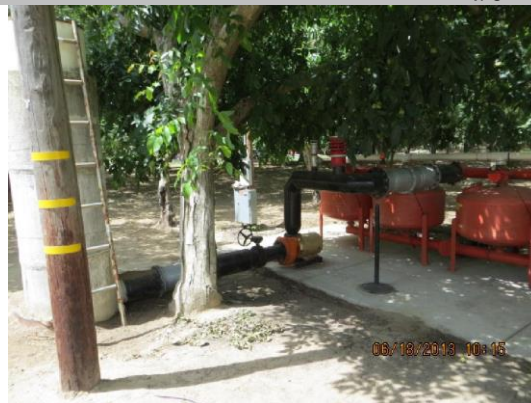
Photo 3 of 3 : UCIP_SP_2019_15285_25086.jpg

Comment Code						
Inspector Comment						
FS_ID:15285 DS_ID:21463 EP_NO: 6100 Repair Type: Non-Urgent Crossing Status: Found UCIP Comments: Gate valve will not open or close. FIELD_STRUCT_DESC: 12-inch steel irrigation pipe through the levee, 3.4 feet below the crown. Slant pump and gate valve on the waterside (WS) slope. Siphon breaker in a 12-inch steel riser on the landside (LS) shoulder. Filter, booster pump, and butterfly valve on the LS toe. 2.25-inch galvanized iron electrical conduit at the same location. (Permit No. 6100, 1968 - Charles Plumb Jr., replaced 8-inch pipe at same location). [Additional Reference(s): DWR Levee Log, 1988]. FS Date: 6/18/2013

Filters, boost pump, and gate valve down stream from concrete standpipe off LS toe.

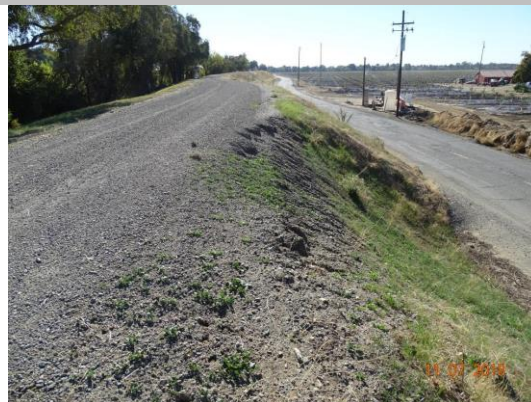
Photo 1 of 2 : SP_2019_RD1600_191_134_20190304_00035.jpg

LM Start	0.97	Rating **	M	Issue No.	134
LM End	0.97	Issue Type +	Ma	Location *	LS
Category	Earthen Levee			GPS Latitude/Longitude	
				Start	End
Item	Erosion / Bank Caving			38.688454 °	38.688454 °
				-121.635528 °	-121.635528 °
DWR ID	DWR_RD1600_01_f_2013_134				
Comment Code					
E2 : Schedule repair of erosion site prior to the next inspection.					
Inspector Comment

View of slope depression and runoff erosion on landside slope. Fall 2018.

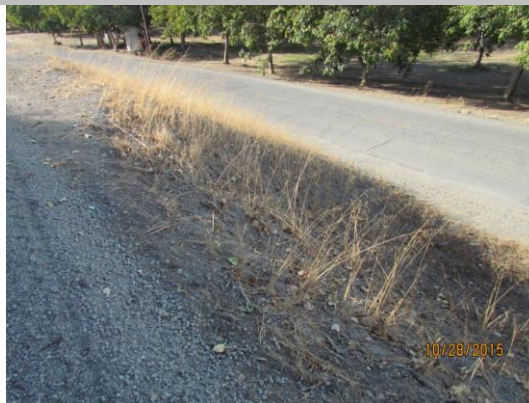
Photo 2 of 2 : SP_2019_RD1600_191_134_20190304_00036.jpg

LM Start	0.97	Rating **	M	Issue No.	134 (cont)	
LM End	0.97	Issue Type +	Ma	Location *	LS	
Category	Earthen Levee			GPS Latitude/Longitude		
				Start		End
Item	Erosion / Bank Caving			38.688454 °		38.688454 °
				-121.635528 °		-121.635528 °
DWR ID	DWR_RD1600_01_f_2013_134					
Comment Code						
E2 : Schedule repair of erosion site prior to the next inspection.						
Inspector Comment

View of the depression of the slope on the landward side of the levee looking downstream. Fall 2015.

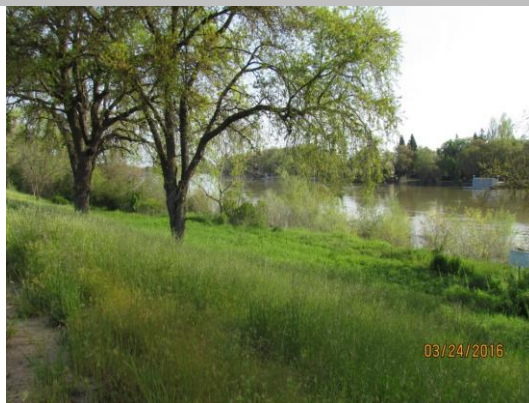
Photo 1 of 2 : SP_2019_RD1600_191_22_20190304_00011.jpg

View of the revegetation site at the berm edge on the waterward side of the levee looking upstream. Spring 2016.

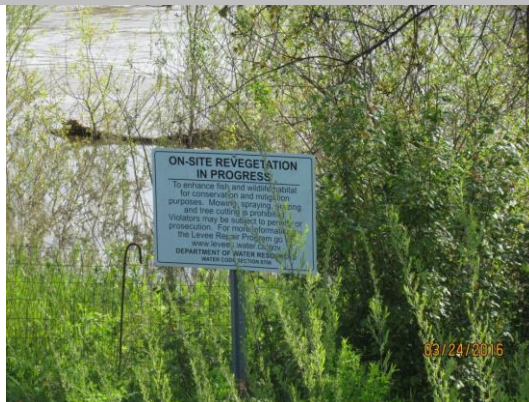
Photo 2 of 2 : SP_2019_RD1600_191_22_20190304_00012.jpg

Sign stating revegetation site. Spring 2016.

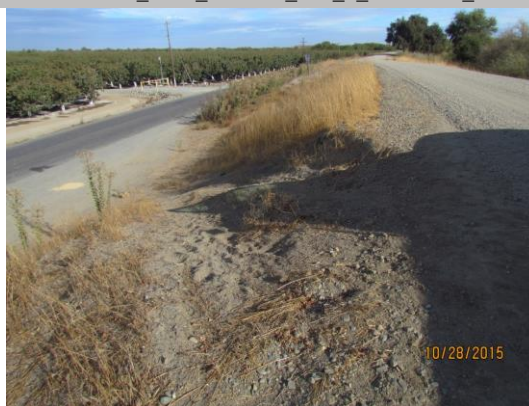
Photo 1 of 1 : SP_2019_RD1600_191_4_20190304_00001.jpg

LM Start	1.40	Rating **	M	Issue No.	4
LM End	1.40	Issue Type +	Ma	Location *	LS
Category	Earthen Levee			GPS Latitude/Longitude	
				Start	End
Item	Slope Stability			38.694452 °	38.694452 °
				-121.634292 °	-121.634292 °
DWR ID	DWR_RD1600_01_s_2017_4				
Comment Code					
S3 : Repair the levee slope damaged by vehicle traffic and prevent access where possible.					
Inspector Comment					
Ruts on the landside slope from vehicles.

View of the slope stability caused by vehicles on the landward side of the levee looking upstream. Fall 2015.

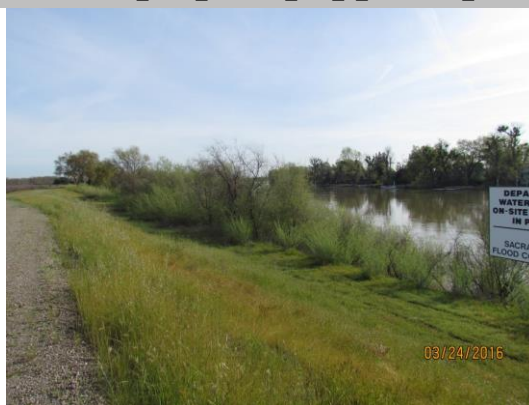
Photo 1 of 2 : SP_2019_RD1600_191_5_20190304_00002.jpg

View of the revegetation site on the berm of the waterward side of the levee looking upstream. Spring 2016.

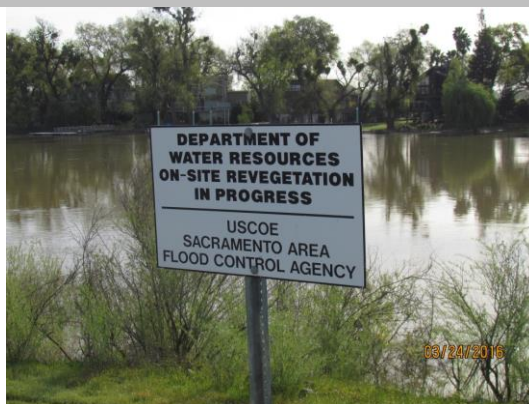
Photo 2 of 2 : SP_2019_RD1600_191_5_20190304_00003.jpg

DWR revegetation site. Spring 2016.

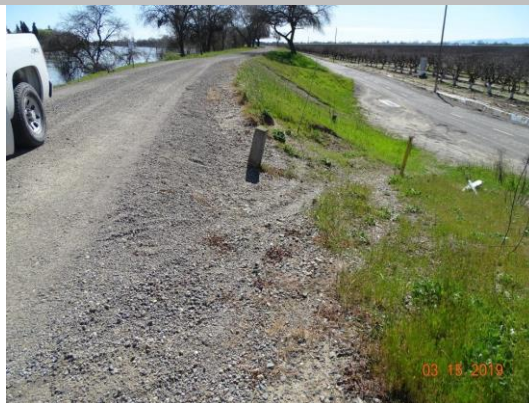
Photo 1 of 1 : SP_2019_RD1600_191_52_20190315_00060.jpg

LM Start	1.42	Rating **	M	Issue No.	52
LM End	1.42	Issue Type +	Ma	Location *	LS
Category	Earthen Levee			GPS Latitude/Longitude	
				Start	End
Item	Slope Stability			38.694728 °	38.694728 °
				-121.634224 °	-121.634224 °
DWR ID	DWR_RD1600_01_f_2018_52				
Comment Code					
S3 : Repair the levee slope damaged by vehicle traffic and prevent access where possible.					
Inspector Comment					
Ruts on the landside slop from vehicles.

View of ruts on landside shoulder. Spring 2019.

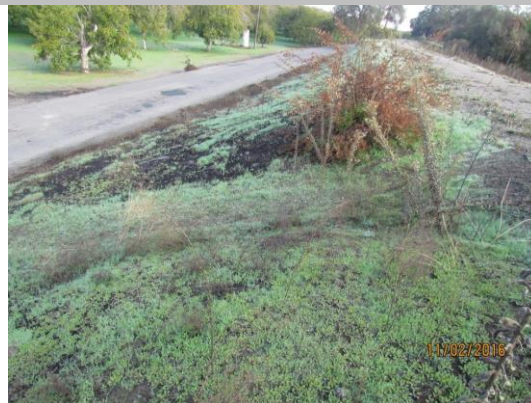
Photo 1 of 1 : SP_2019_RD1600_191_70_20190304_00030.jpg

LM Start	1.70	Rating **	A/W	Issue No.	70
LM End	1.70	Issue Type +	Ma	Location *	LS
Category	Earthen Levee			GPS Latitude/Longitude	
				Start	End
Item	Slope Stability			38.698414 °	38.698414 °
				-121.631874 °	-121.631874 °
DWR ID	DWR_RD1600_01_f_2017_70				
Comment Code					
S2 : Repair the levee slope damaged by foot traffic and prevent access where possible.					
Inspector Comment					
Footpath on landside slope. Recommend monitoring.

View of slope instability. Fall 2016.

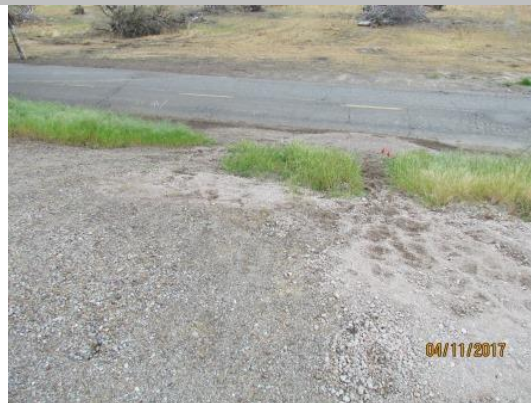
Photo 1 of 1 : SP_2019_RD1600_191_72_20190304_00031.jpg

LM Start	2.01	Rating **	M	Issue No.	72
LM End	2.01	Issue Type +	Ma	Location *	LS
Category	Earthen Levee			GPS Latitude/Longitude	
				Start	End
Item	Erosion / Bank Caving			38.701605 °	38.701605 °
				-121.627954 °	-121.627954 °
DWR ID	DWR_RD1600_01_s_2018_72				
Comment Code					
E2 : Schedule repair of erosion site prior to the next inspection.					
Inspector Comment					
Runoff on landside slope.

View of the erosion site. Spring 2017.

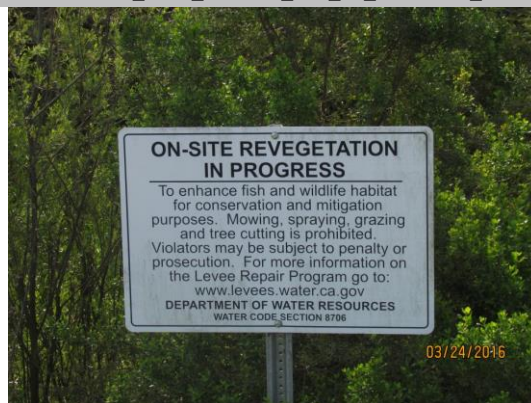
Photo 1 of 2 : SP_2019_RD1600_191_35_20190304_00019.jpg

Sign for revegetation site. Spring 2016.

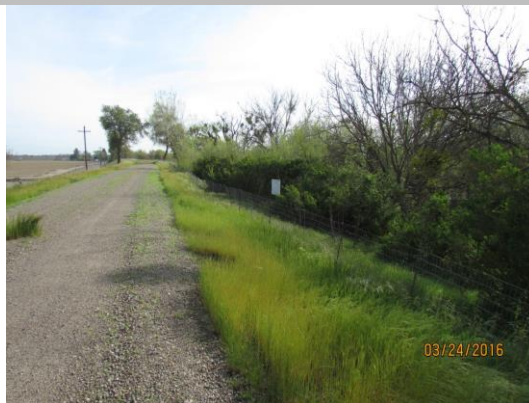
Photo 2 of 2 : SP_2019_RD1600_191_35_20190304_00020.jpg

View of the revegetation site on the waterward side of the levee looking upstream. Spring 2016.

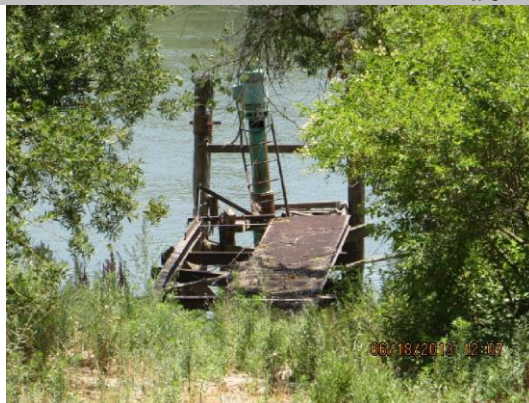
Photo 1 of 3 : UCIP_SP_2019_15108_24826.jpg

Comment Code					
Inspector Comment					
FS_ID:15108					
DS_ID:21467					
EP_NO: N/A					
Repair Type: Non-Urgent					
Crossing Status: Not Found					
UCIP Comments: Pipe removed and replaced with a pipe dsid 25565 - permit 18852.					
Appears abandoned and should be done so properly. Debris buildup on pier. Power cut to pump.					
FIELD_STRUCT_DESC: *REMOVED* 16-inch steel irrigation pipe through the levee, 2 feet below the crown. Walkway from berm to pump on pile structure in the stream. Siphon breaker on the landside (LS) slope. 12-inch polyvinyl chloride (PVC) standpipe off the LS toe. [Additional Reference(s): DWR Levee Log, 1988. USACE Sacramento O&M Manual 123, August 1955, (RM 73.4) (18-inch pipe listed)].					
FS Date: 6/18/2013

Pump on metal platform off WS berm.

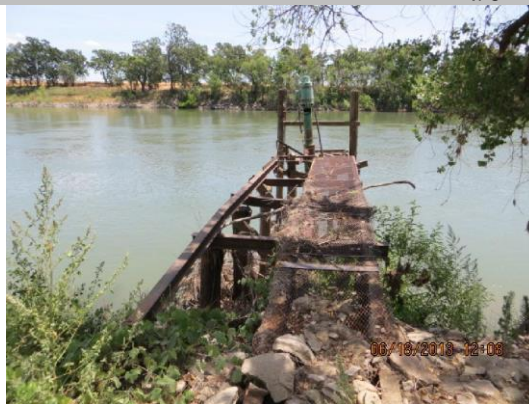
Photo 2 of 3 : UCIP_SP_2019_15108_24825.jpg

Debris buildup at metal platform waterline.

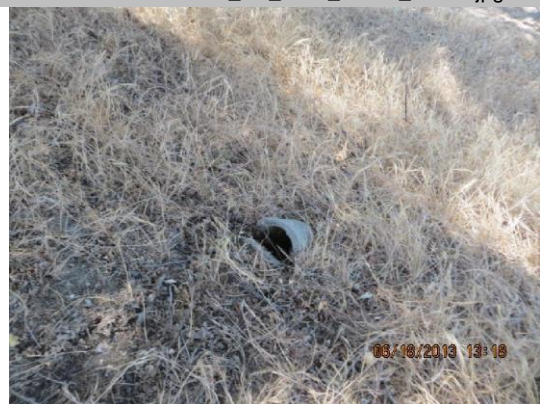
Photo 1 of 2 : UCIP_SP_2019_15110_24828.jpg

Pipe visible on LS slope.

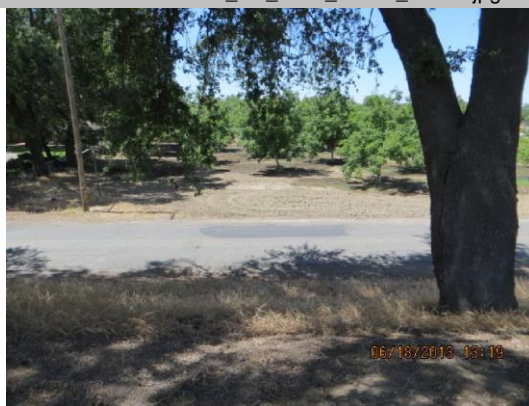
Photo 2 of 2 : UCIP_SP_2019_15110_24827.jpg

Pipe visible on LS slope.

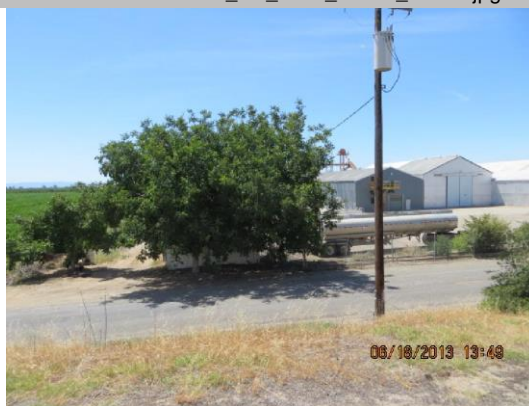
Photo 1 of 3 : UCIP_SP_2019_15125_24846.jpg

Pumphouse/distribution box off LS toe.

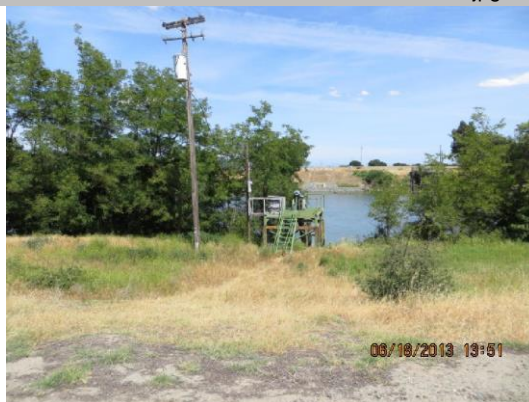
Photo 2 of 3 : UCIP_SP_2019_15125_24845.jpg

Slant pump on metal pier on WS berm.

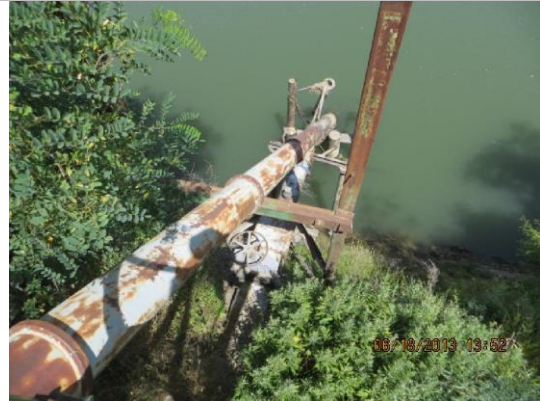
Photo 3 of 3 : UCIP_SP_2019_15125_24844.jpg

16-inch pipe ties into 24-inch pipe under pump platform at slide gate.

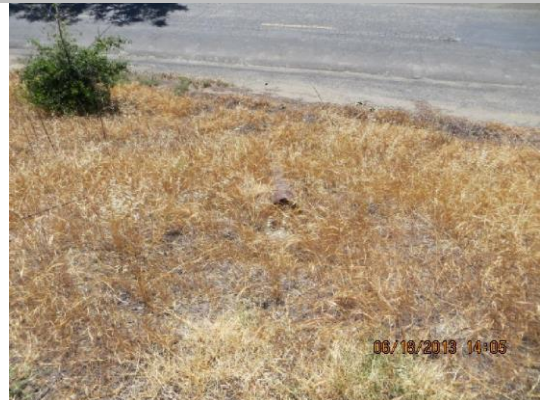
Photo 1 of 2 : UCIP_SP_2019_41563_27474.jpg

Pipe and remnants of grouted pipe on LS slope.

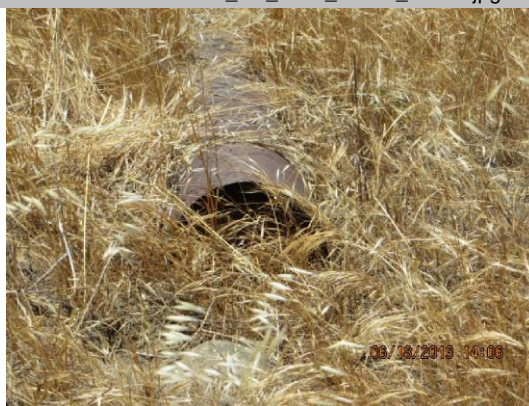
Photo 2 of 2 : UCIP_SP_2019_41563_27473.jpg

Pipe and remnants of grouted pipe on LS slope.

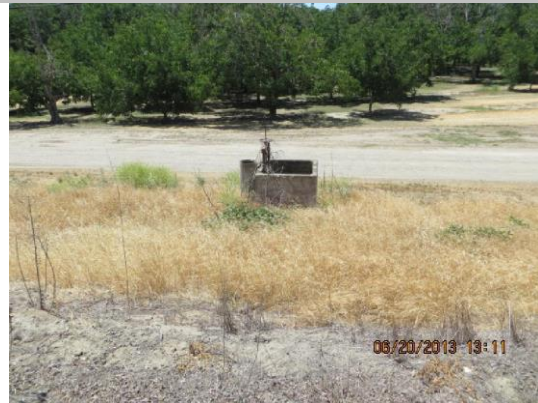
Photo 1 of 3 : UCIP_SP_2019_53410_25011.jpg

6'X6' concrete distribution box on LS toe.

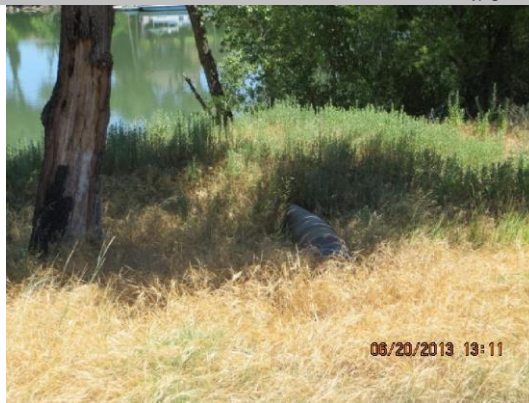
Photo 2 of 3 : UCIP_SP_2019_53410_25010.jpg

Pipe on WS slope.

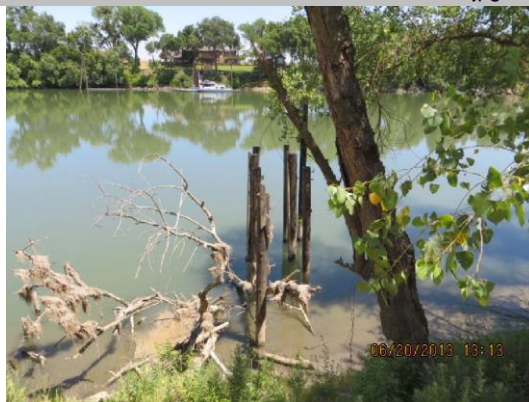
Photo 3 of 3 : UCIP_SP_2019_53410_25012.jpg

Pump missing from pier on WS toe.

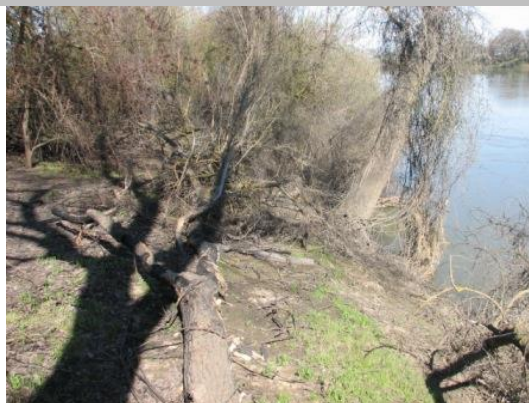
Photo 1 of 2 : SP_2019_RD1600_191_20_20190304_00006.jpg

This another view of the site.

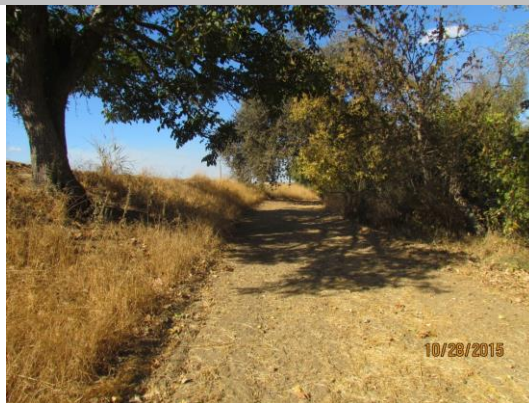
Photo 2 of 2 : SP_2019_RD1600_191_20_20190304_00007.jpg

View of the erosion in the berm area on the waterward side looking upstream. Fall 2015.

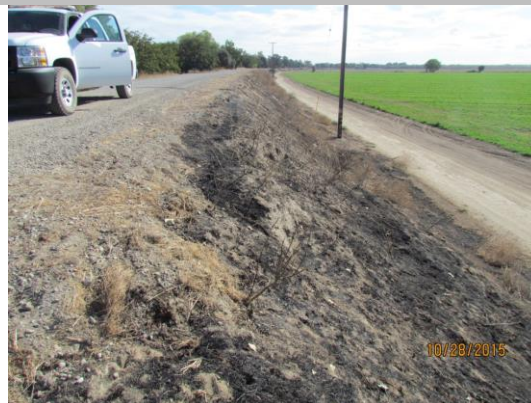
Photo 1 of 1 : SP_2019_RD1600_191_61_20190304_00028.jpg

View of the erosion on the landward side of the levee looking downstream. Fall 2015.

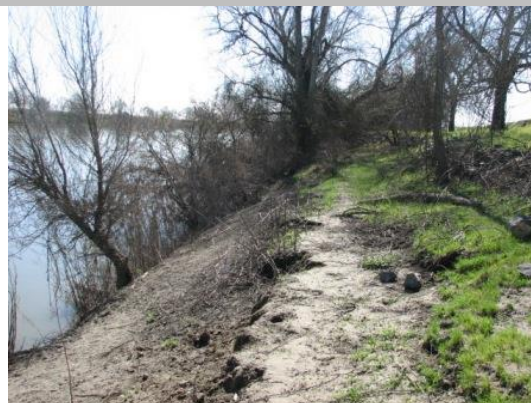
Photo 1 of 3 : SP_2019_RD1600_191_21_20190304_00008.jpg

The erosion is eroding away the berm area.

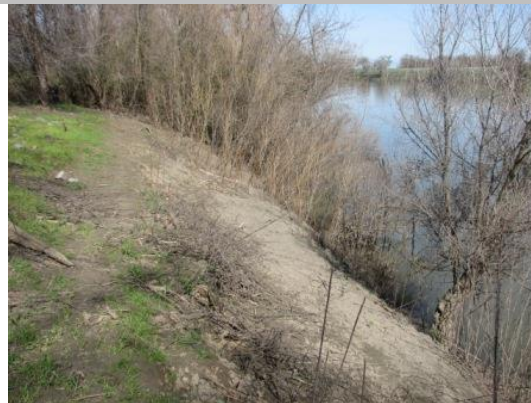
Photo 2 of 3 : SP_2019_RD1600_191_21_20190304_00009.jpg

The bank is eroding away and has become very steep.

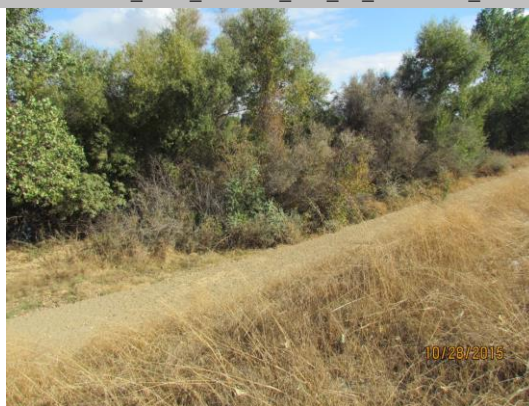
Photo 3 of 3 : SP_2019_RD1600_191_21_20190304_00010.jpg

View of the erosion along the waterward berm of the levee. Fall 2015.

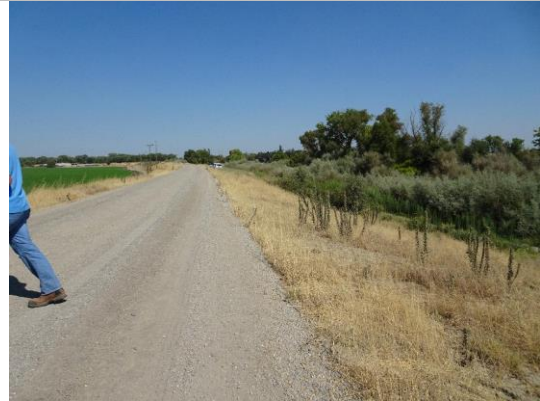
Photo 3 of 3 : UCIP_SP_2019_50169_75609.jpg

view of levee crown looking upstream from pipe location.

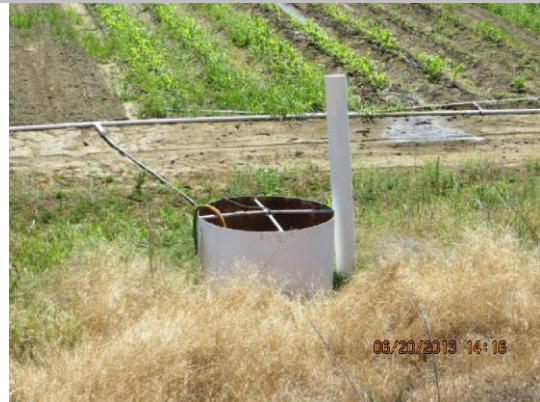
Photo 1 of 1 : UCIP_SP_2019_16310_27485.jpg

4-foot diameter steel standpipe at LS toe, may be indicator of pipe location.

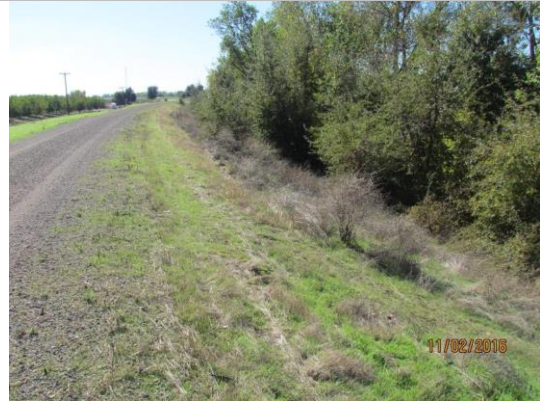
Photo 1 of 1 : SP_2019_RD1600_191_66_20190304_00029.jpg

Vegetation on WS slope has been cleared only about 10 ft. from the crown. Fall 2016.

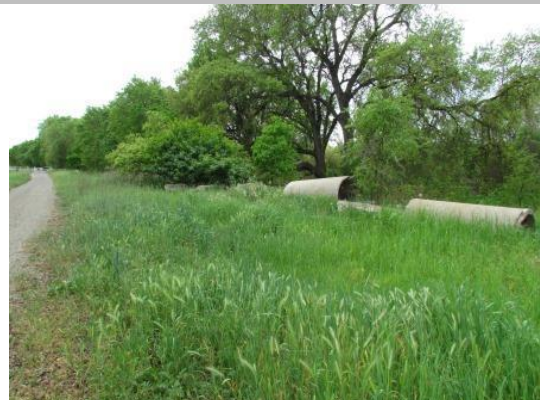
Photo 1 of 1 : SP_2019_RD1600_191_1202_20190304_00038.jpg

View of debris on the waterward side of the levee looking upstream.
Spring 2015.

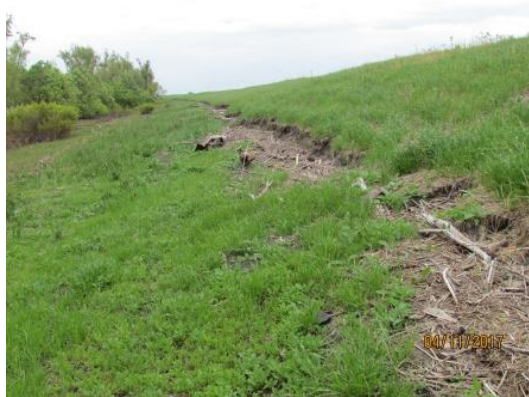
Photo 1 of 1 : SP_2019_RD1600_192_23_20190304_00016.jpg

View of wave wash damage on waterside levee slope. Spring 2017.

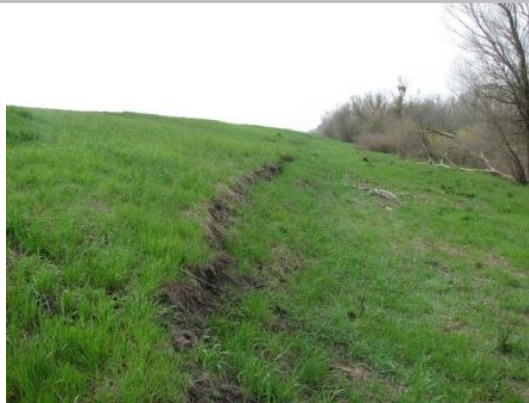
Photo 2 of 4 : SP_2019_RD1600_192_14_20190304_00006.jpg

Wave wash damage along the slope the cut is 1'-2'.

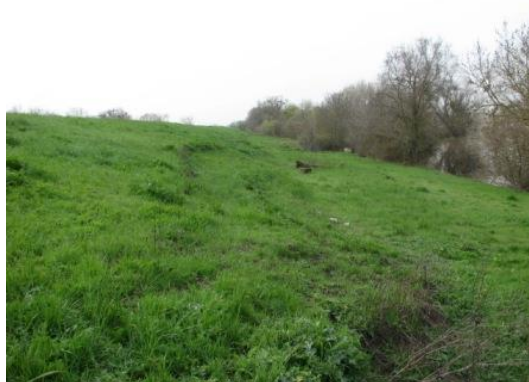
Photo 2 of 3 : SP_2019_RD1600_192_15_20190304_00010.jpg

This is wave wash damage along the toe of the levee looking downstream.

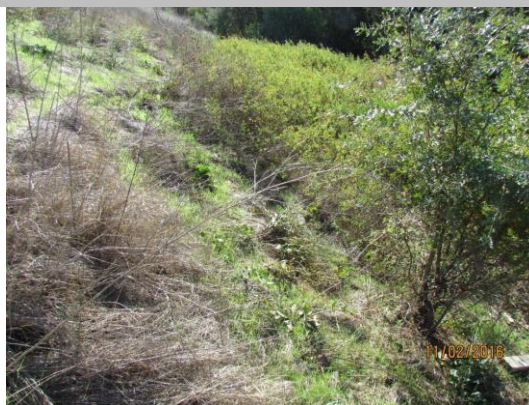
Photo 3 of 3 : SP_2019_RD1600_192_15_20190304_00011.jpg

View of wave wash damage on WS slope. Fall 2016.

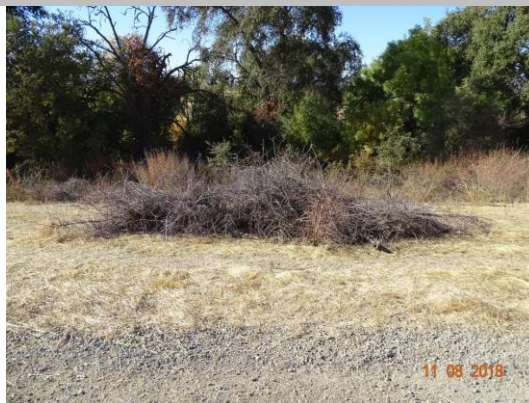
Photo 1 of 1 : SP_2019_RD1600_192_20_20190304_00015.jpg

View of pruning pile on the waterside slope. Fall 2018.

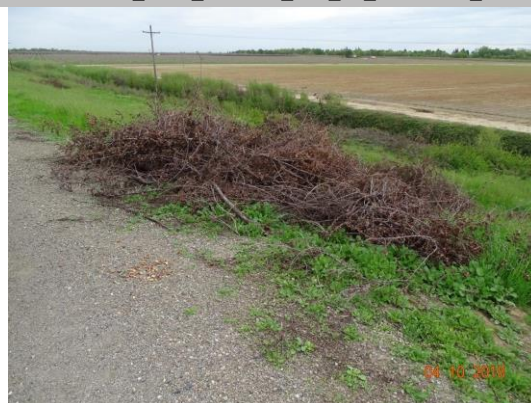
Photo 1 of 1 : SP_2019_RD1600_192_10_20190304_00004.jpg

View of pruning pile on the landside slope. Spring 2018.

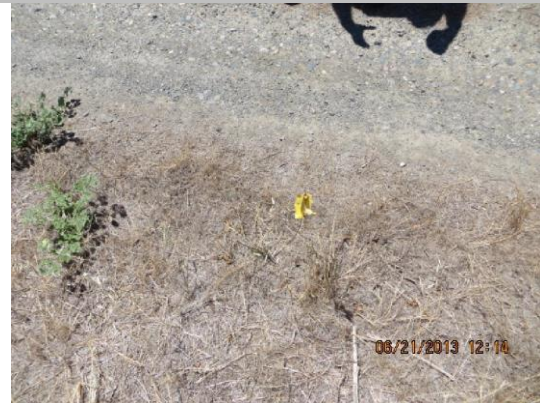
Photo 1 of 3 : UCIP_SP_2019_52738_27478.jpg

PG&E marker flag on Crown.

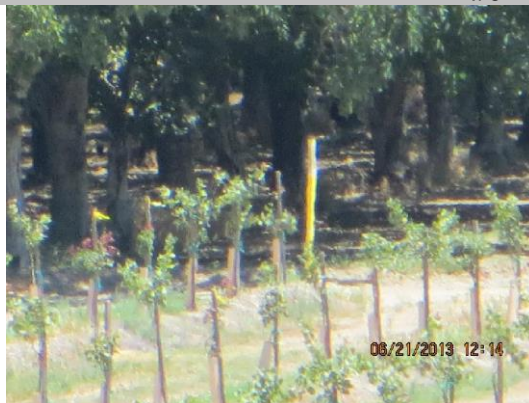
Photo 2 of 3 : UCIP_SP_2019_52738_27477.jpg

Carsonite gasline marker visible approximately 1,000-feet east of levee crown.

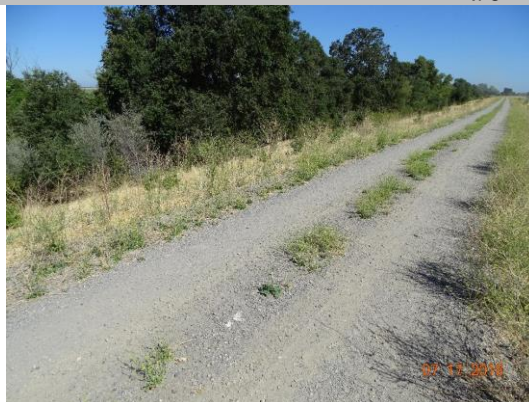
Photo 3 of 3 : UCIP_SP_2019_52738_77709.jpg

View of levee crown at potential crossing looking upstream.

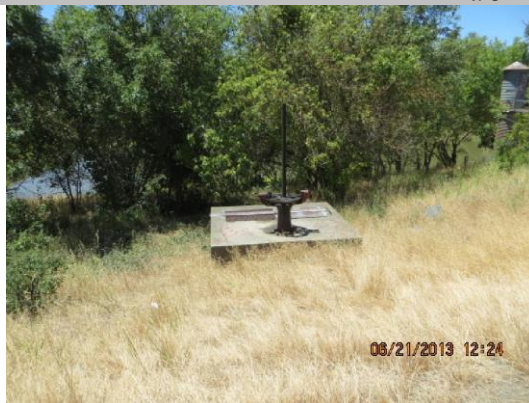
Photo 3 of 3 : UCIP_SP_2019_15303_25156.jpg

Slide gate in 9'X10' concrete box on WS slope.

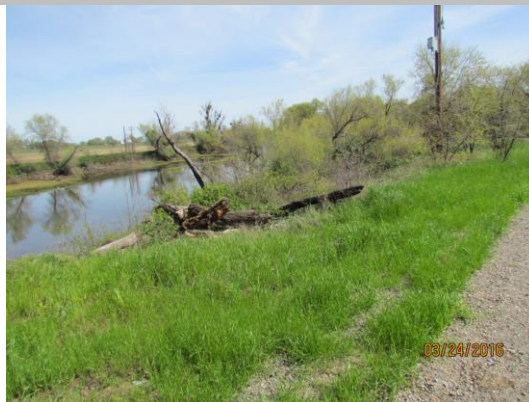
Photo 1 of 2 : SP_2019_RD1600_192_6_20190304_00002.jpg

View of the trees on the landward side of the levee looking downstream.
Spring 2016.

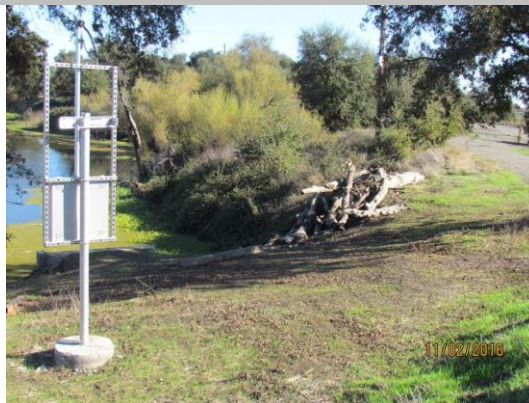
Photo 2 of 2 : SP_2019_RD1600_192_6_20190304_00003.jpg

View of debris on LS slope. Fall 2016.
